Manhole Inspection Summary

Manhole # S06AA2003MH

Insp Date: **6/28/06 10:15 AM**

Location Address: **6805 GIST AVE**

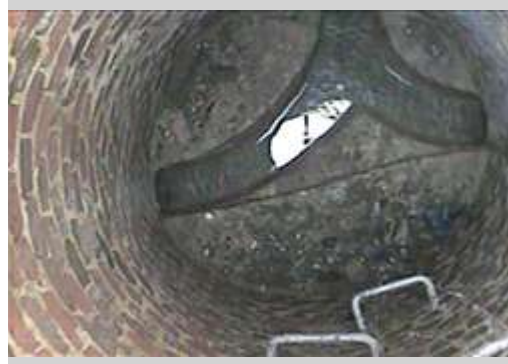
Top View

Adjustment and Barrel infiltration.
Evidence of surcharge - Bench debris.

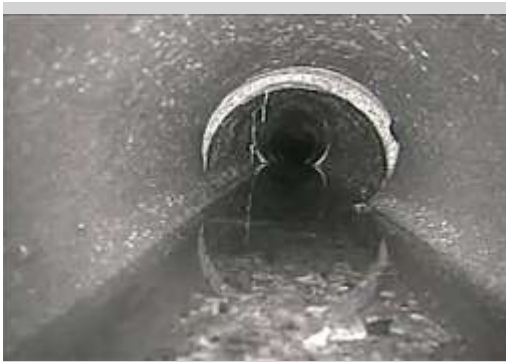
Inside of the O12

Offset joint in the O12.

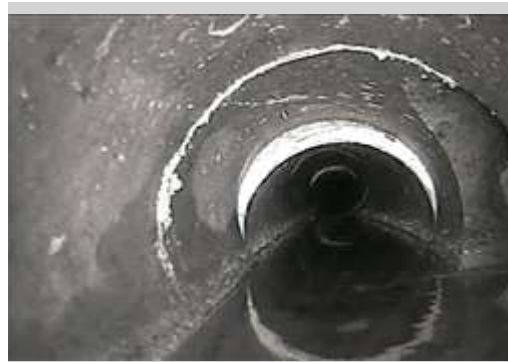
Inside of the I3

Offset joint in the I3.

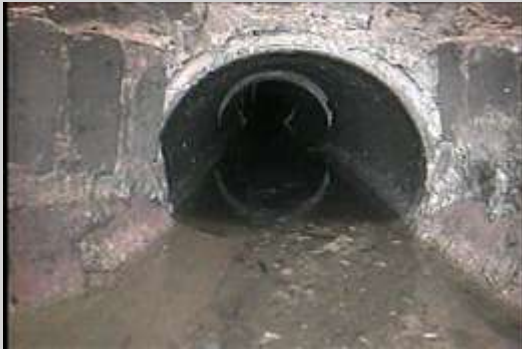
8 in. Circular Gravity Sewer Pipe Out @ 12 O'Clock

Comments **Both the O12 and the I9 pipe pictures show grease deposits in the Channel and inside of the pipe.**

Deposits: ☐ None ☒ **Mud** ☐ Sludge ☒ **Debris** ☐ Grease

Silt Depth: **1** (in.) Deposits Extent: **Light**

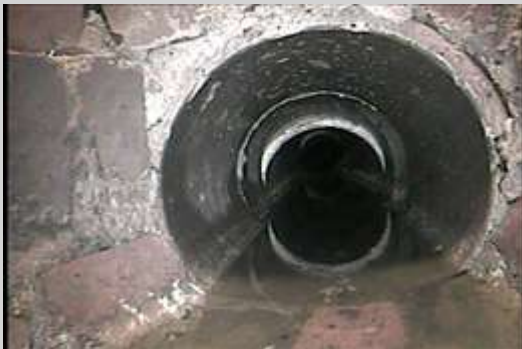
8 in. Circular Gravity Sewer Pipe In @ 3 O'Clock

Deposits: ☐ None ☒ **Mud** ☐ Sludge ☒ **Debris** ☒ **Grease**

Infiltration: **Evidence** Pipe Seal Cond: **Cracked**

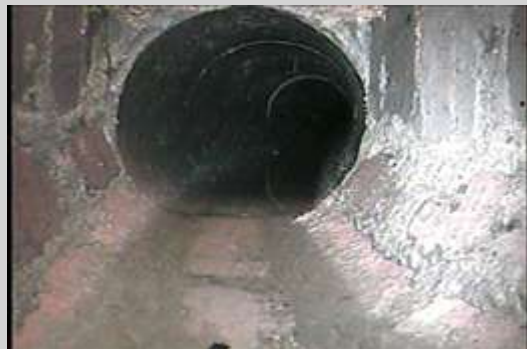
Pipe In @ 9 O'Clock

Infiltration: **Evidence**

Pipe Seal Cond: **Cracked**
